Manhole Inspection Summary

Manhole # S43WW_007MH

Insp Date: **2/16/07 2:01 PM**

Location Address: **2840 THE ALAMEDA**

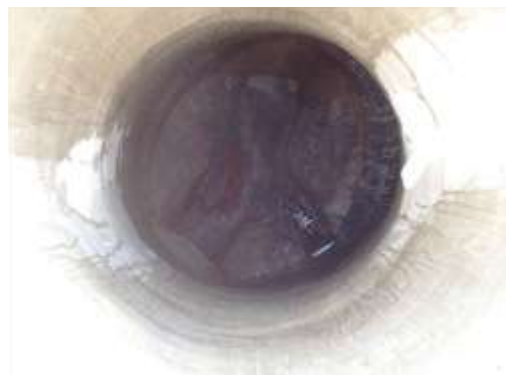
Top View

Corbel infiltration. Bench debris.

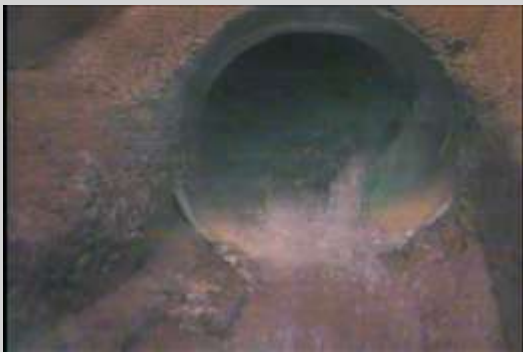
10 in. Circular Gravity Sewer Pipe Out @ 12 O'Clock

Pipe Material: **Unknown** ☒ Pipe Lined

Invert Depth: **9.25** (ft.) Flow Characteristics: **Fast**

Infiltration: **None** Pipe Seal Cond: **Unknown**

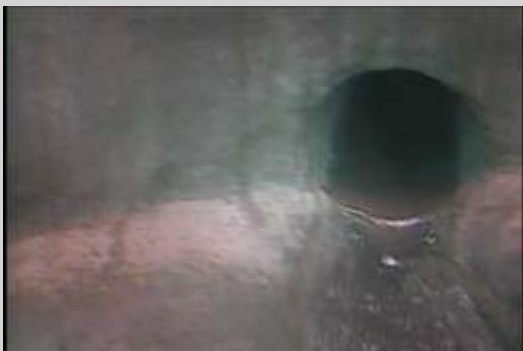
8 in. Circular Gravity Sewer Pipe In @ 5 O'Clock

Pipe Material: **Unknown** ☐ Pipe Lined

Invert Depth: **8.45** (ft.) Flow Characteristics: **Slow**

Infiltration: **None** Pipe Seal Cond: **Unknown**

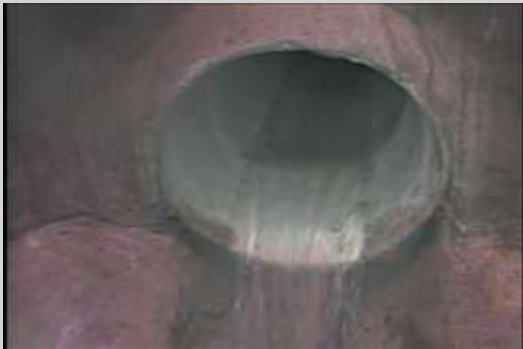
12 in. Circular Gravity Sewer
Pipe In @ 7 O'Clock

Pipe Material: **Unknown** ☒ Pipe Lined

Invert Depth: **8.00** (ft.) Flow Characteristics: **Fast**

Infiltration: **None** Pipe Seal Cond: **Unknown**
